Minerals Inspection Report

| Mine Name: Eikins #2 | Permit Number: S/49/0088 | Mine Status: Active |
| Operator Name: SK Materials LLC | Inspection Date: 03/06/2014 | Permit Fees: Paid |
| Inspection Purpose: Determine if earthwork grading is acceptable prior to seeding | | Prior Inspection: not previously in |

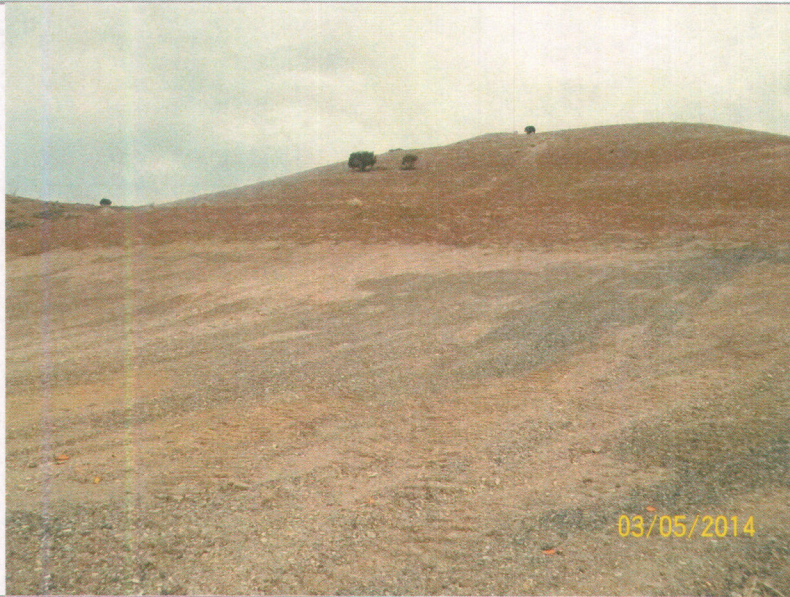
| Elements of Inspection | | Evaluated & Commented | Enforcement |
|---|--|---|---|
| The slope grade is acceptable to the Division. Mr. Clement intends to move the permit further east. We discussed that it would be necessary to provide a new map showing the updated permit boundary. | | | |

Slope of reclaimed material facing north at the Eikins 2 pit.

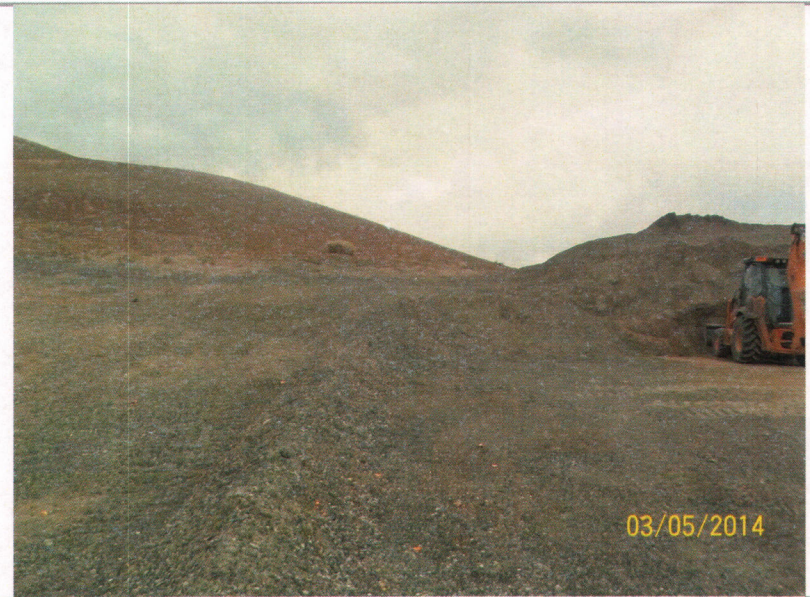
| Elements of Inspection | | Evaluated & Commented | Enforcement |
|---|--|---|---|
| The operator intends to move the operation eastward while concurrently reclaiming and maintain the same bond amount. This is acceptable practice. However, the Division requests that a map be submitted as an amendment to the permit when the permit boundary area changes. Form MR-REV on the Minerals Program website is used to submit amended changes to the mine plan. | | | |

View of the reclaimed area and active area boundary.

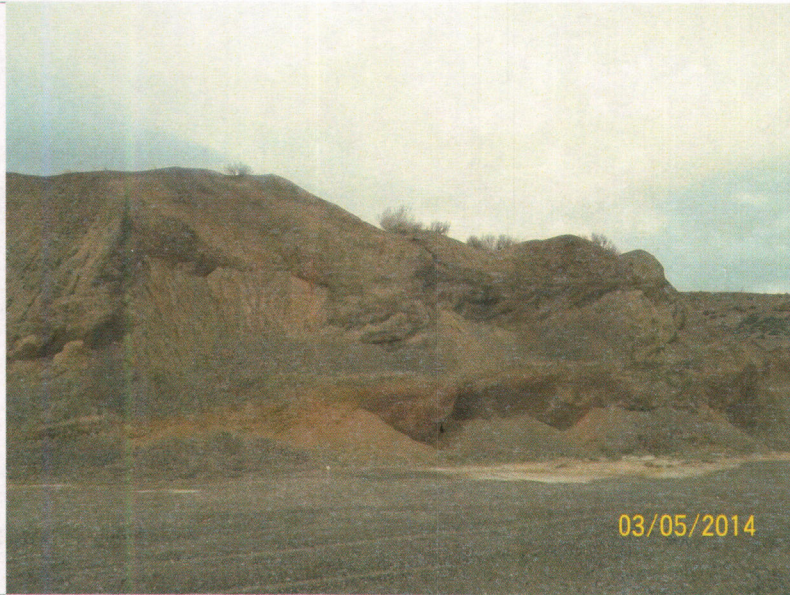
| Elements of Inspection | | Evaluated & Commented | Enforcement |
|---|--|---|---|
| The stockpile the west of his property is situated an an unsafe angle creating a public safety hazard. This material was originally agreed to be staged there for road base material per the property owner's wishes. However, the stockpile has been sitting there for years untouched. The operator is willing to voluntarily grade this material down for safety purposes. The Division recommends that this should be done. | | | |

Stockpile of road base located on the adjacent private property to the west. Material is at an unsafe slope and needs to be brought down to an approximate 3:1 slope.

Stockpile grade is acceptable and ready for seeding this spring. Contact the property owner to ask about the status of the road base stockpile. Explain that it is a safety hazard and needs to be graded down. Requested a new permit boundary map from the operator.

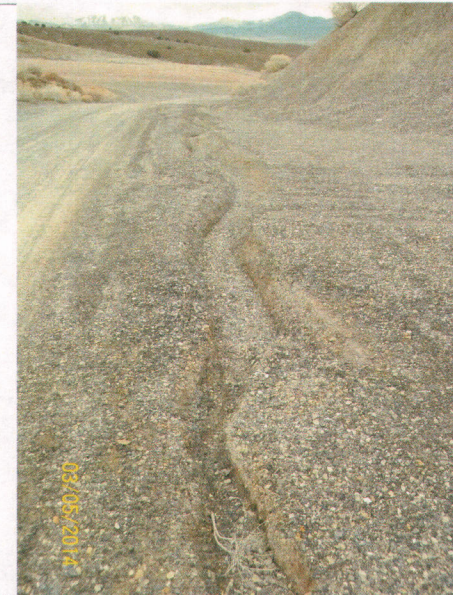
| Elements of Inspection | | Evaluated & Commented | Enforcement |
|---|--|---|---|
| The access road to the permit area had erosion problems at the base of the road base stockpile. Run off was causing rilling along the side of the road. This is not the operator's responsibility to maintain since it is off their permit area; however, the land owner should take care of this issue and blade a ditch alongside the road for better drainage. | | | |

Access road had an erosion problem alongside the base of the road base stockpile and needs to be regraded with a ditch to better manage runoff.
